AN INVESTIGATION OF THE AIR FLOW AROUND A MARTIN

PBM-3 FIYING BOAT BY MEANS OF TUFTS

## MEMORANDUM REPORT

Bureau of Aeronautics, Navy Department

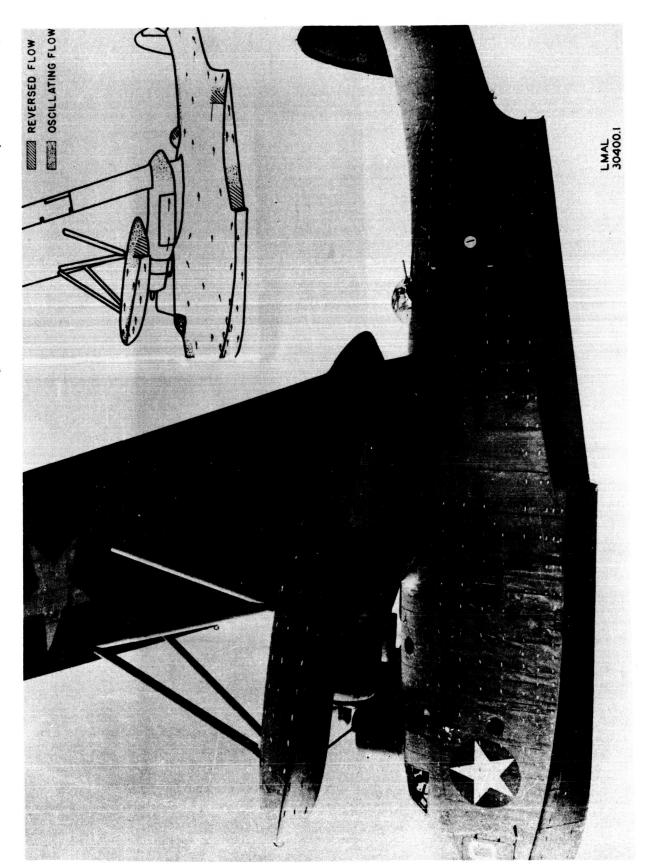
Above the chine along the sides of the hull, the flow was generally parallel to the direction of flight. The effect of the wing in deflecting the flow over the hull is plainly evident in figure 2. The flow over the tail extension, at an airspeed of 94 knots (fig. 2), was smooth and nearly parallel to the base line; no separation was apparent in this region. The flow around the stern post was affected to a large extent by the separation at the vertical step on the sides of the afterbody. Behind the main step, turbulence extended aft approximately 10 feet; from this point to the stern post, the flow along the bottom of the hull was smooth.

The effect of changes in flight speed and attitude upon the flow over the wing-tip floats is shown in figures 2, 5, 6, and 8. At 94 knots the tufts on the bottom of the float indicated a strong flow toward the chine; the tufts just above the chine were steady and appeared to stand away from the surface, again indicating a strong vortex in this region. The cross flow was still present at 166 knots, although it was less pronounced than at the lower speeds. The flow over the afterbody of the float and behind the strut fittings was turbulent at all speeds; however, the turbulence decreased at higher speeds.

Flow over a PBM-3 hull at 94 knots, indicated airspeed. Figure 2.-

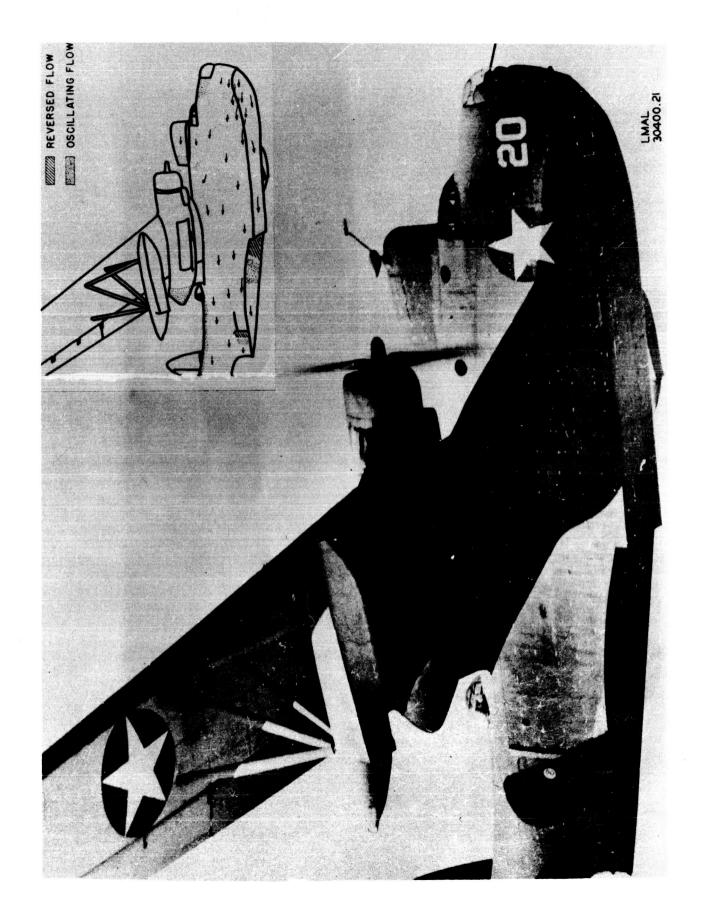
The flow over the starboard side of the hull was generally similar to that observed on the port side.

Figure 3.- Flow over a PBM-3 hull at 94 knots, indicated airspeed.

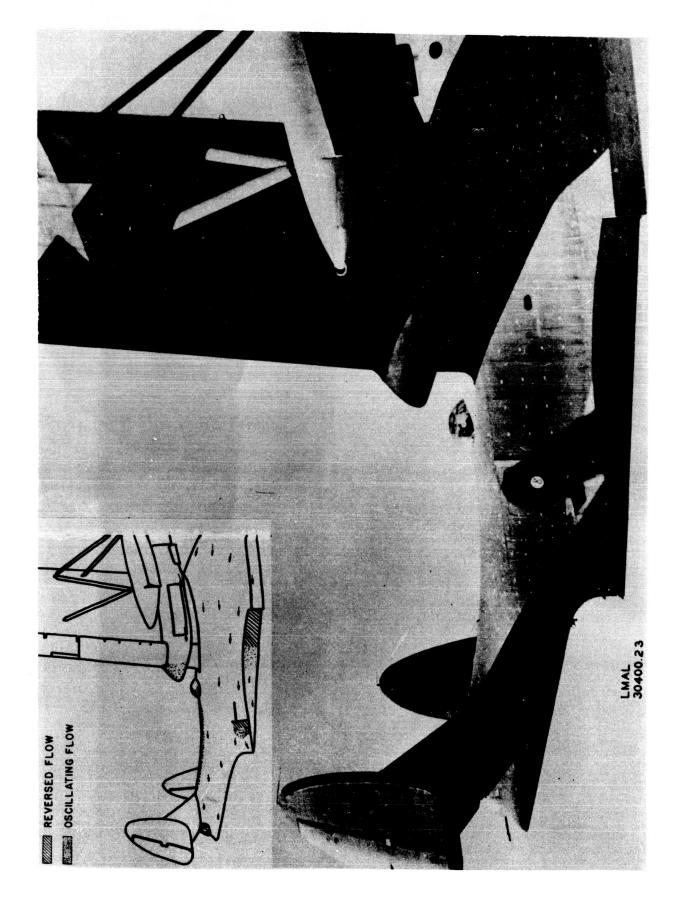
Figure 4.- Flow over a PBM-3 hull at 94 knots, indicated airspeed.

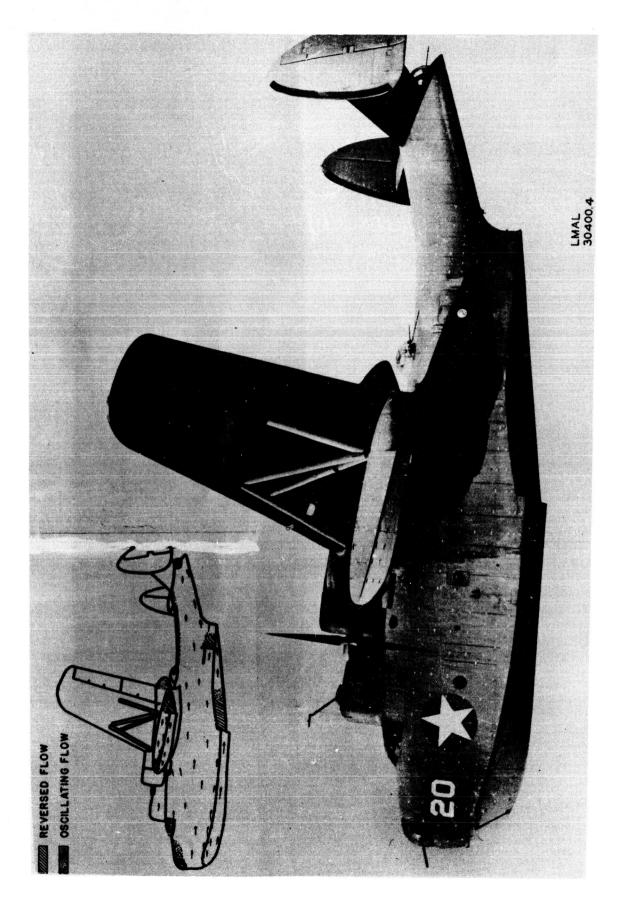
Increasing the airspeed from 94 to 116 knots caused only slight changes in the flow over the hull, as may be seen by comparing figures 2 and 5. The angle between the

relative wind and the hull was decreased approximately 5°, and the tufts over most of the hull therefore lie more nearly parallel to the base line at the higher airspeed. Similar small changes in direction of flow were noted when the speed was increased from 116 to 137 knots. (See figs. 6 and 7.)

Figure 5.- Flow over a PBM-3 hull at 116 knots, indicated airspeed.

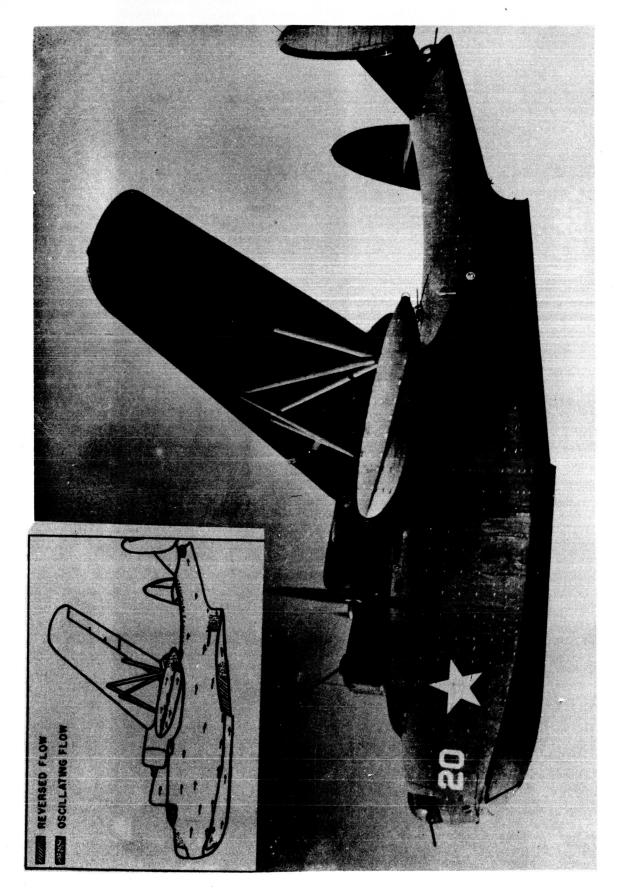
Figure 6.- Flow over a PBM-3 hull at 137 knots, indicated airspeed.

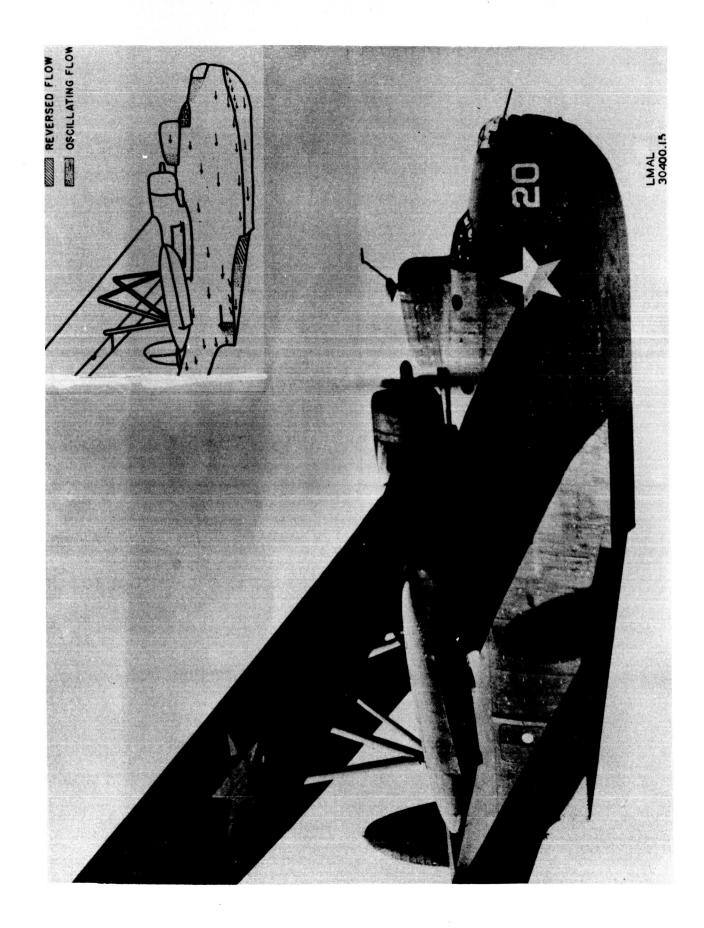
Figure 7.- Flow over a PBM-3 hull at 137 knots, indicated airspeed.

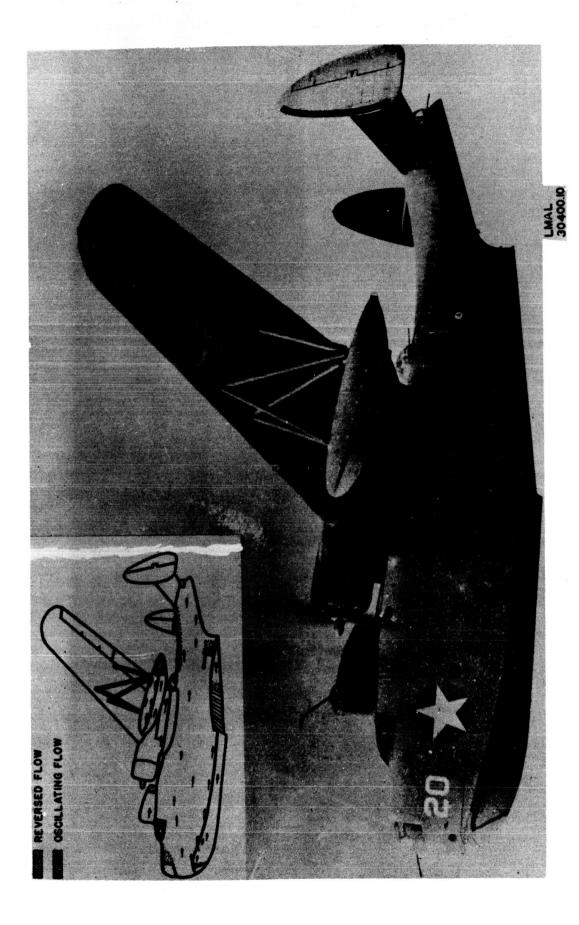
At 166 knots (the high-speed attitude) the flow along the sides of the hull was parallel to the base line (figs. 8 and 9). The inclination of the tufts along the forebody chine indicates an appreciable reduction in cross flow over this corner. Turbulence behind the main step, however, appeared to extend somewhat farther aft at this speed than for the lower speeds.

Figure 8.- Flow over a PBM-3 hull at 166 knots, indicated airspeed.

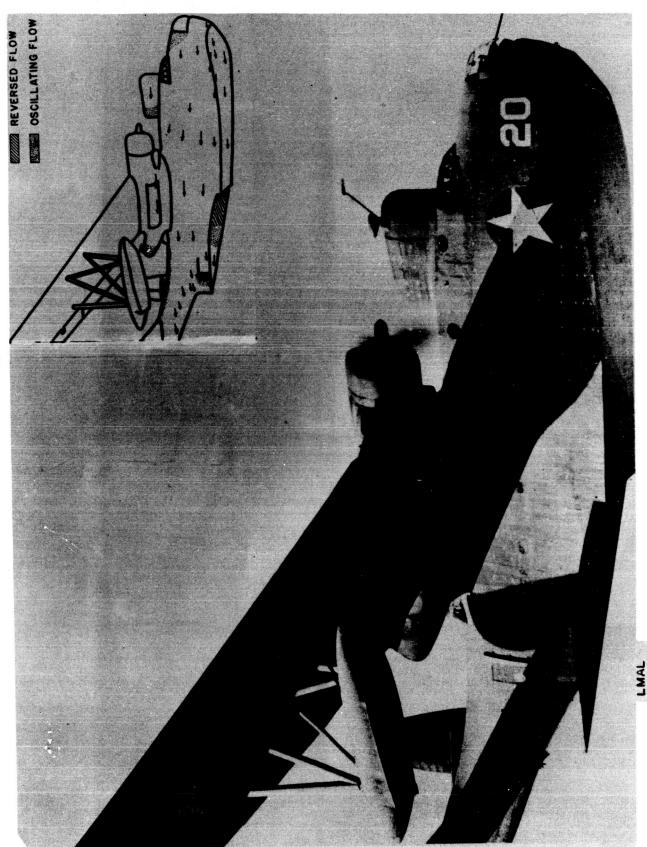
Flow over a PBM-3 hull at 166 knots, indicated airspeed. Figure 9.-
